## Study of Wear Resistance of Antifriction Materials for Bushings of Lever-Hinge Mechanism of Lifting Installation Brake System

**Abstract.** This article examines the pressing scientific and practical challenge of improving the operational reliability and wear resistance of friction units in lever-hinge mechanisms (LHM) of mine hoist braking systems. The authors provide a detailed analysis of the kinematics and operating characteristics of pin-sleeve friction units using equipment operated at the Kamyshinskaya and Artemyevskaya mines as an example. It is demonstrated that severe operating conditions - high radial loads ( $80 \div 150$  kN), alternating pulses, constant vibration, and the presence of abrasive dust - lead to the degradation of protective oxide films, fretting corrosion, and an avalanche-like increase in radial clearances in the hinges. Bushing wear triggers dangerous edge pressures, fatigue stresses in the pin body, and a sharp drop in the mechanical efficiency of the drive. To address this issue, comprehensive comparative tribological tests of various antifriction materials were conducted using a ball-on-disk design on a Microtest automated tribometer under stric

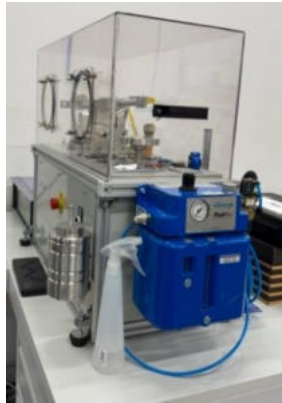
Fig. 2. - Microtest tribometer

Tribological studies were conducted using a ball-on-disk friction system on a Microtest tribometer (Microtest, SA, Madrid, Spain, Figure 2) under the following experimental conditions:

- sliding distance – 100 m;
- sliding speed – 150 rpm;
- trajectory radius – 2 mm;
- load – 10 N;
- test temperature – 22.3°C;
- time – 27 min.

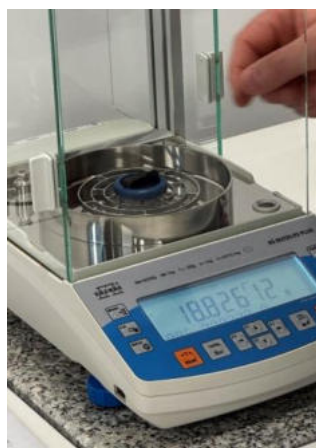
Fig. 4. - Laboratory scales AS 60/220.R2 PLUS Analytical Balance

The degree of wear of the overlay material was assessed by weighing the test specimens before and after testing on an analytical balance (Figure 4).

Ball weight loss was recorded on a laboratory scale with an accuracy of 0.00001%, and sample weight loss was recorded with an accuracy of 0.001%.
