## Study of Wear Resistance of Antifriction Materials for Bushings of Lever-Hinge Mechanism of Lifting Installation Brake System

**Abstract.** This article examines the pressing scientific and practical challenge of improving the operational reliability and wear resistance of friction units in lever-hinge mechanisms (LHM) of mine hoist braking systems. The authors provide a detailed analysis of the kinematics and operating characteristics of pin-sleeve friction units using equipment operated at the Kamyshinskaya and Artemyevskaya mines as an example. It is demonstrated that severe operating conditions - high radial loads ( $80 \div 150$  kN), alternating pulses, constant vibration, and the presence of abrasive dust - lead to the degradation of protective oxide films, fretting corrosion, and an avalanche-like increase in radial clearances in the hinges. Bushing wear triggers dangerous edge pressures, fatigue stresses in the pin body, and a sharp drop in the mechanical efficiency of the drive. To address this issue, comprehensive comparative tribological tests of various antifriction materials were conducted using a ball-on-disk design on a Microtest automated tribometer under stric

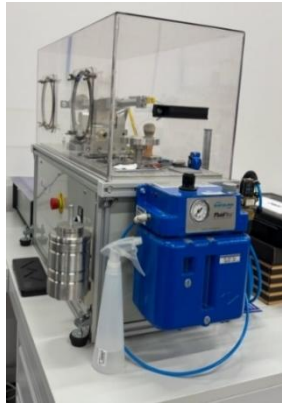
Fig. 2. - Microtest tribometer

Tribological studies were conducted using a ball-on-disk friction system on a Microtest tribometer (Microtest, SA, Madrid, Spain, Figure 2) under the following experimental conditions:

- sliding distance – 100 m;
- sliding speed – 150 rpm;
- trajectory radius – 2 mm;
- load – 10 N;
- test temperature – 22.3°C;
- time – 27 min.

The specimen was mounted in the Microtest tribometer disk holder, whose design ensures rigid fixation and prevents its displacement during testing. The specimen was positioned in the holder's mounting socket so that its working surface was strictly perpendicular to the load axis of the counterbody. The center of the specimen was aligned with the tribometer's rotation axis, ensuring the formation of a closed annular friction path of a specified radius.

The specimen was secured using the holder's clamping mechanism (screw or clamp type), ensuring uniform distribution of force across the entire contact area between the specimen and the supporting surface of the holder. The tightening torque of the clamping elements was selected to prevent both sample slippage and deformation, which could lead to distorted measurement results.

After mechanical clamping, the alignment and horizontality of the specimen's working surface relative to the plane of rotation were checked. This was done visually and using the tribometer's indicator equipment. Permissible surface runout deviations did not exceed the values recommended by the equipment manufacturer, ensuring stable contact conditions throughout the entire test cycle.

A counterbody, a standard 6 mm diameter ball made of AISI 52100 (100Cr6) steel, was installed in the upper holder of the tribometer and secured according to the manufacturer's instructions. After installing the counterbody, the ball was preliminarily applied to the specimen surface without load to precisely position the contact zone at the specified radius of the friction path.

Before the main experiment, the system was calibrated using a normal load, after which a specified load of 10 N was applied. Only after contact conditions had stabilized was the specimen rotated at a set sliding speed of 150 rpm. The test temperature was controlled and matched to room temperature (22.3°C).

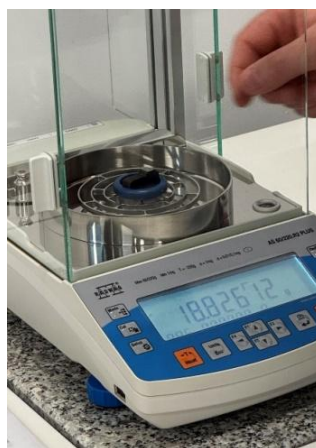
Fig. 4. - Laboratory scales AS 60/220.R2 PLUS Analytical Balance

The degree of wear of the overlay material was assessed by weighing the test specimens before and after testing on an analytical balance (Figure 4).

Ball weight loss was recorded on a laboratory scale with an accuracy of 0.00001%, and sample weight loss was recorded with an accuracy of 0.001%.
